HELLENIC TRAIN- RAILWAY COMPANY SOCIETE ANONYME

INVESTIGATION

on Accident dynamics, explosion, and fire

Collision between Intercity train 62 and freight train 63503
on 28 February 2023

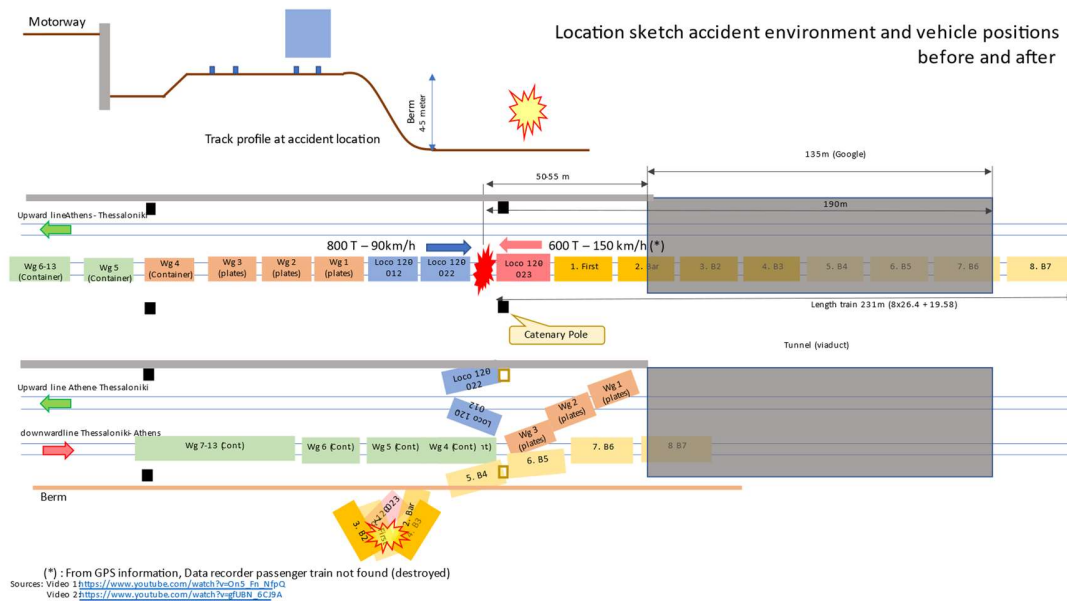
Figure 1: Location sketch infrastructure and vehicles before and after the crash

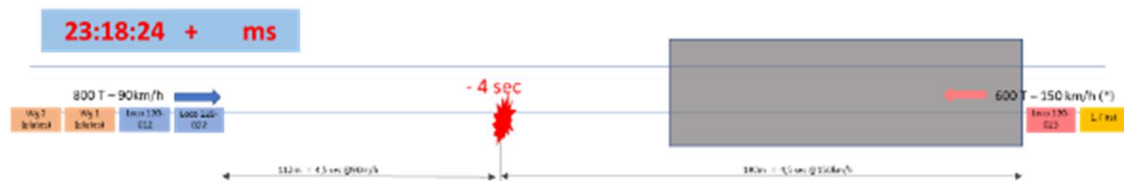
From the surveillance video¹ on the motorway south of the accident we can see that the freight train and passenger train drivers did not expect a collision as we cannot observe that an emergency brake has been applied. The location of the crash itself is hidden from the camera by the motorway viaduct. As it was night and the track is slightly curved in that area, with the tunnel/viaduct in between, the head-on collision could not be seen until the very last moment and not at all possible to apply the brakes with any effect.

Figure 2: Overview with timing as per video camera from the motorway (for simplicity the tracks are shown straight)

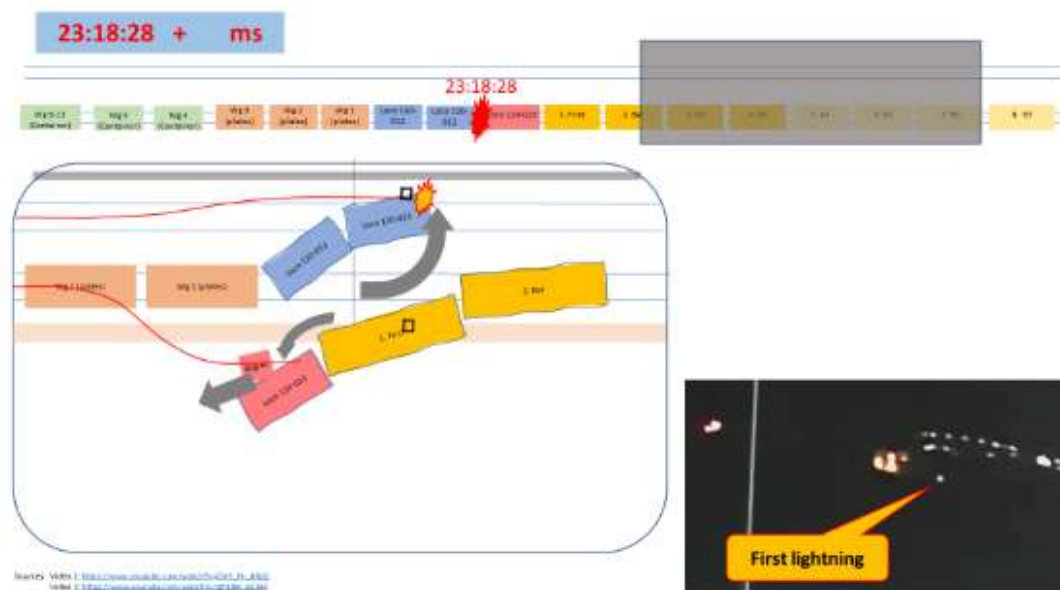
This led to a rather hard short-circuit of the upward overhead line with limited flashes (they are not visible, or the line was not powered due to earlier problems). The second freight locomotive 120-012 crushed in the first and while most likely stay coupled together till the last moment, turned around and becoming in opposite direction against the first to standstill (electrical coupler were still connected see Figure 13).

Figure 3: First lightning

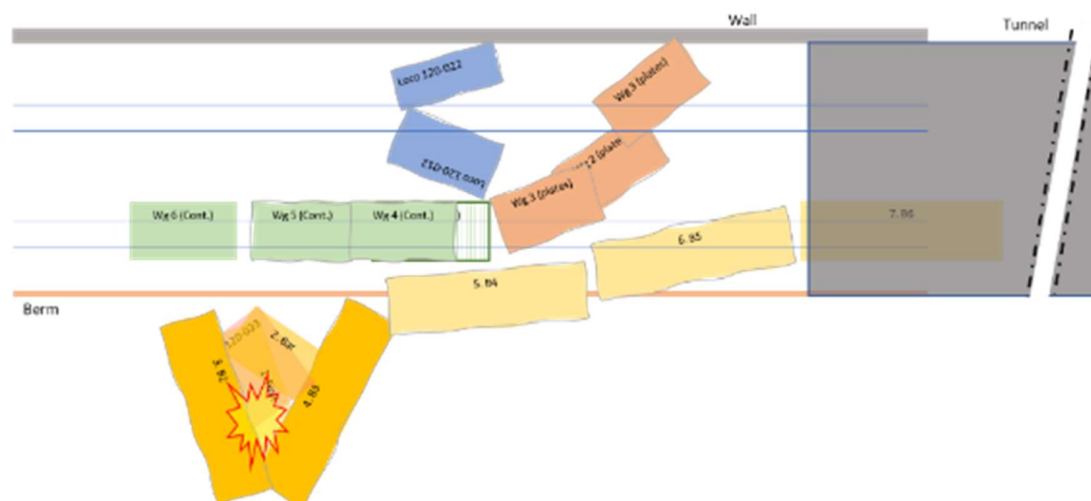
Figure 4: sketch position vehicles after the crash

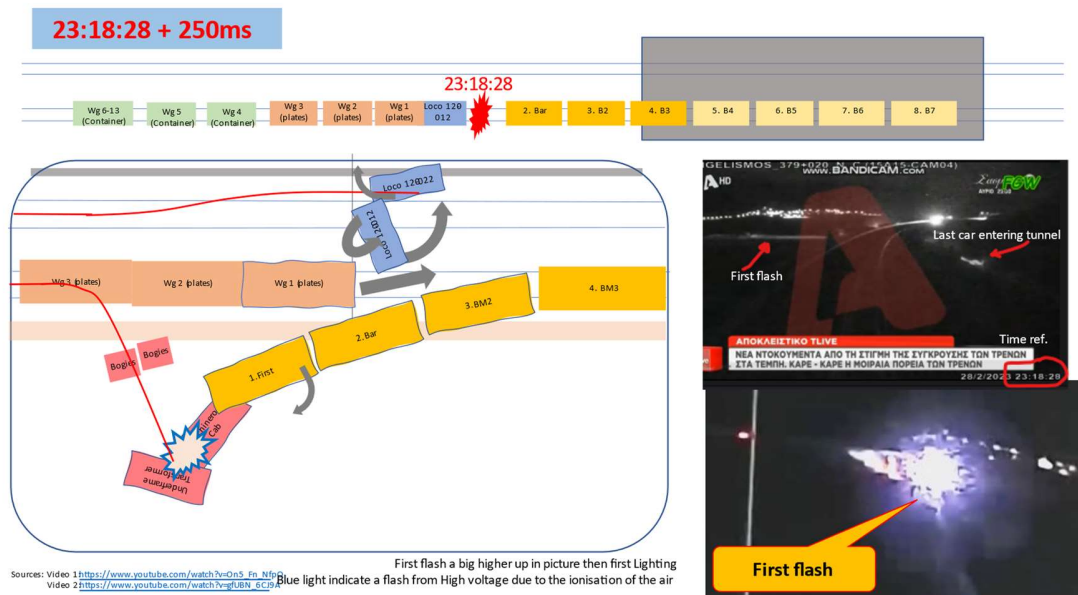
Since the locomotive was catapulted in the air for circa 30 meters to the 5-meter lower berm, the overhead line came only to a short circuit the moment the locomotive hits the ground. From the video 2, we can see that it took 2 to 3 flashes (blue light) in the same location with the last one the biggest before the overhead line (25kV) was switched off² (see Figure 5 and Figure 6).

Figure 5: first arc flash overhead line

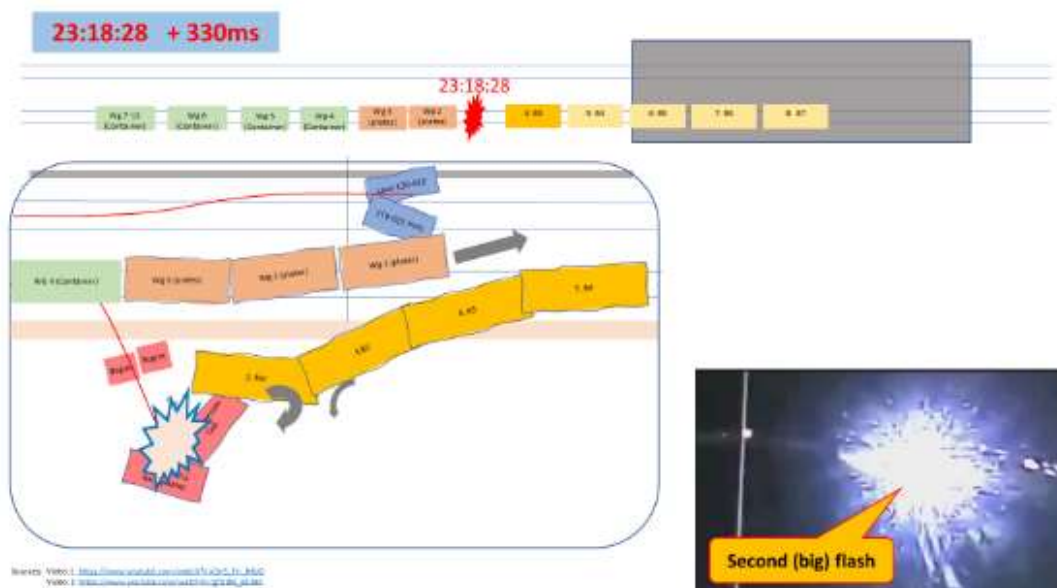
Figure 6: Second arc flash overhead line

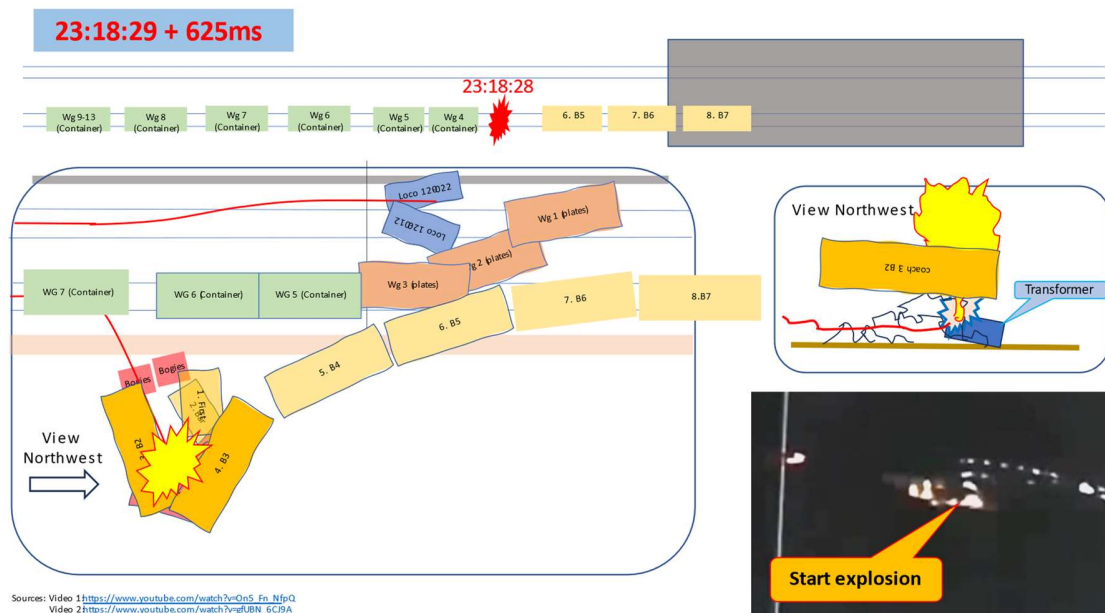
The 2-3 arc flashes from the High voltage short-circuit seen on the video 2 are all happening at the same location and immediately right after the last and biggest short-circuit flash the explosion happened. Looking into the video in slow motion, we can see that the last glow of the short-circuit flash raising and fade away while from below the light of the explosion become visible. Interesting to notice is that the light become visible from behind an object, depending on the position of the camera (exact location unknown at this time), this should most likely be coach B2. This is the location where the transformer is laying on the ground in the corner between coach B2 and coach B3. Both are laying about 3 meters higher on the debris of the locomotive and the first cars.

Figure 7: Sketch Start explosion

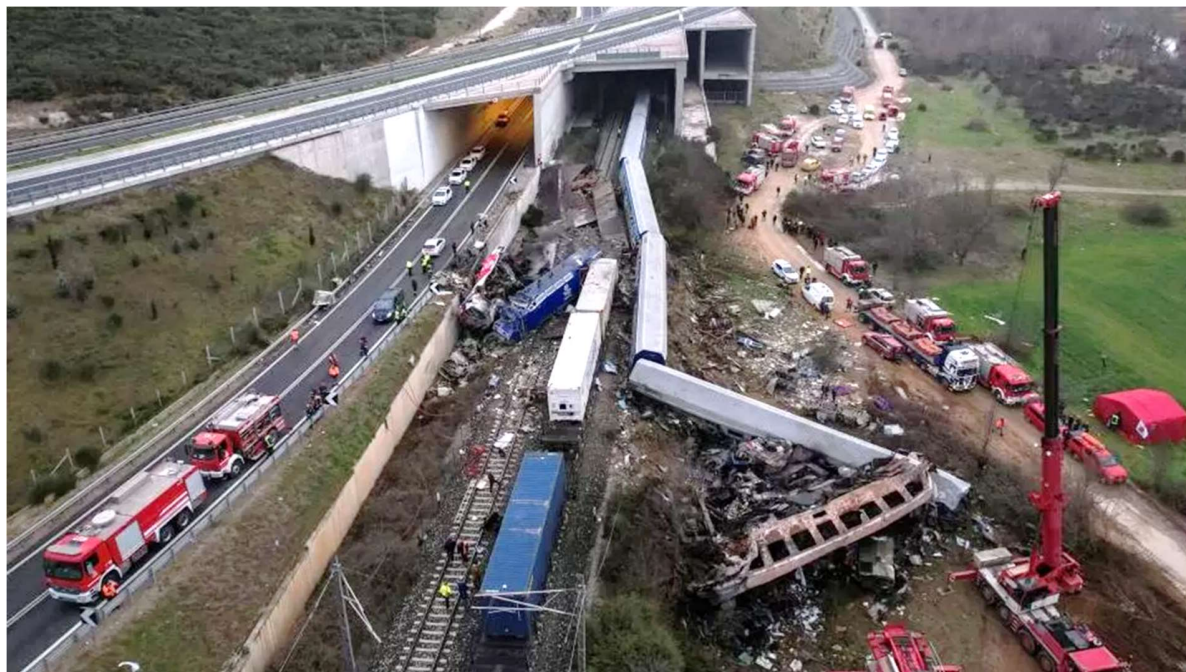
The event also unrolls on the other side with the freight train. The 3 freight wagons with steel plates behave a bit differently than the other vehicles in the collision. As can be observed from the position of the wagons and the locomotives, the flat wagons and heavy steel plates (different size from 10-25mm – 2 to 5 ton/plate) glided underneath the locomotives and continue their trajectory along the track till standstill in front of the locomotives (Figure 10).

Figure 10: Overview vehicle positions after the crash

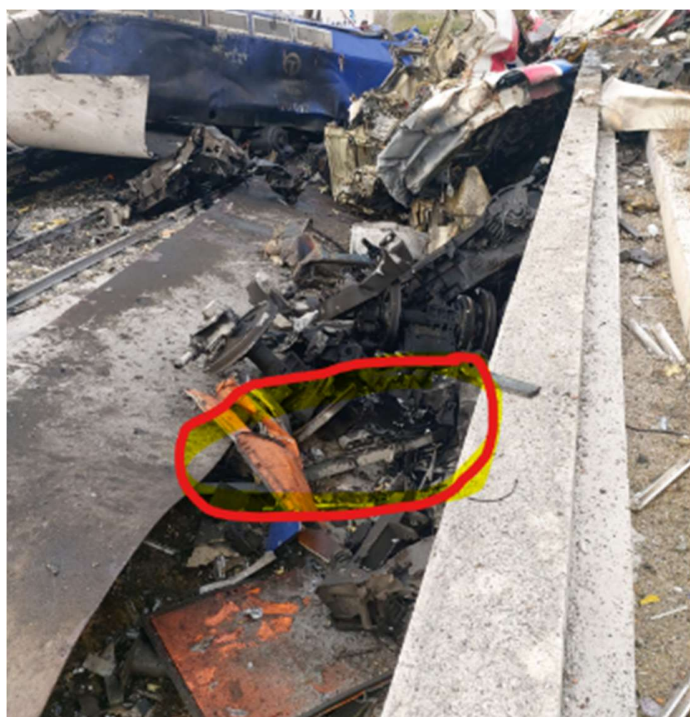
The first freight locomotives 120-022 was catapulted over the upward line track (driving direction leftwards) and heavily smashed against the motorway wall with equipment going over the wall (Figure 9). The locomotive most likely jumped up (headstock bended downwards) and took the overhead pole and catenary line with it in the crash trajectory as the catenary and catenary pole can be found under the locomotives (see Figure 11 and Figure 12).

Figure 11: Catenary pole downward line under freight locomotive (2023-03-01 16.46.00.jpg)

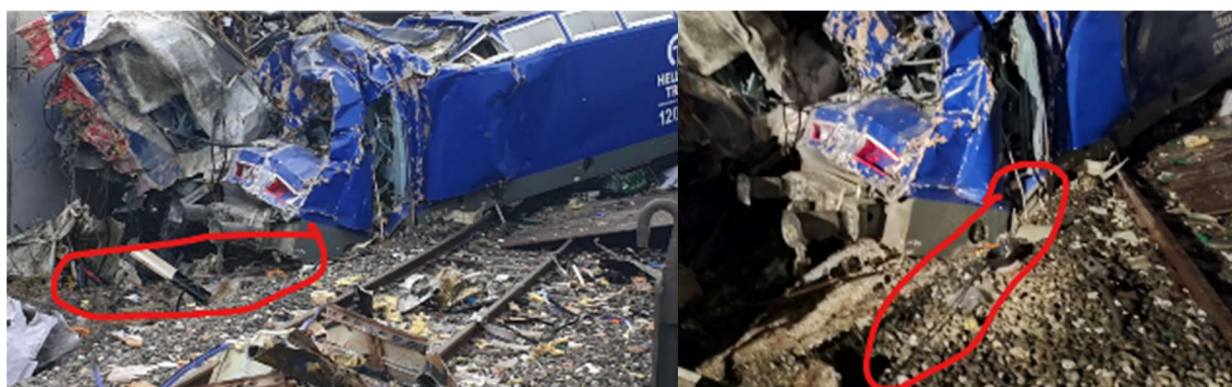
Figure 12: Catenary line under freight locomotive (20230301-105223.jpg & 20230301-034238.jpg)

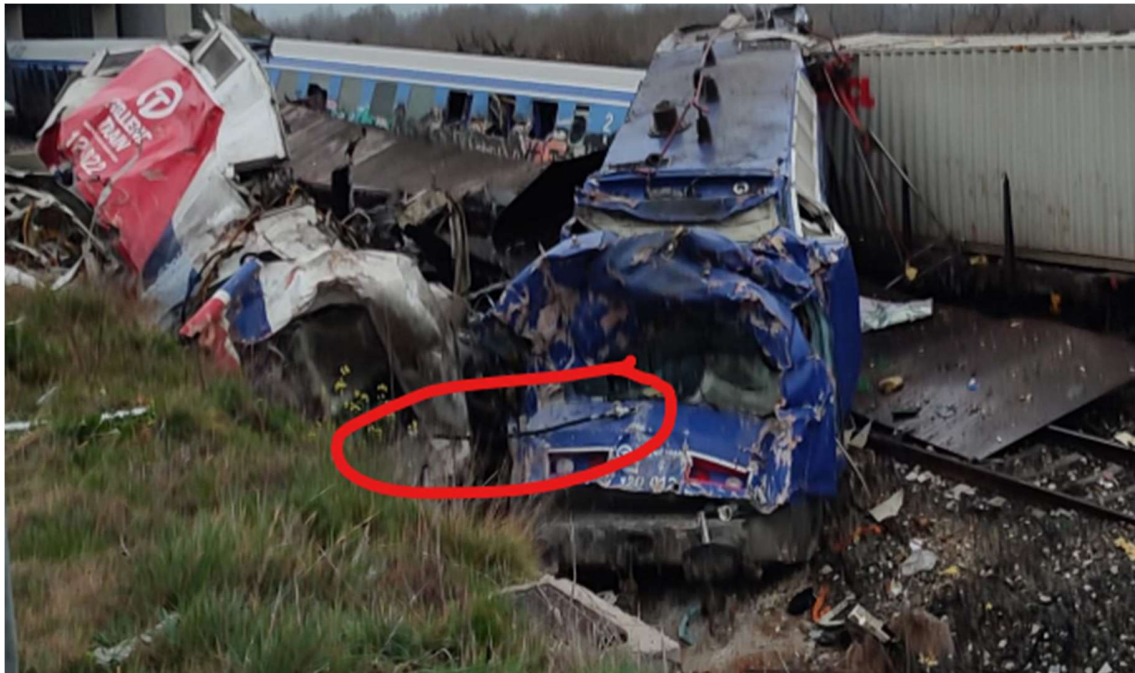
Figure 13: Freight locomotives - Still electrical connected (UIC-plugs) (20230301-071311.jpg)

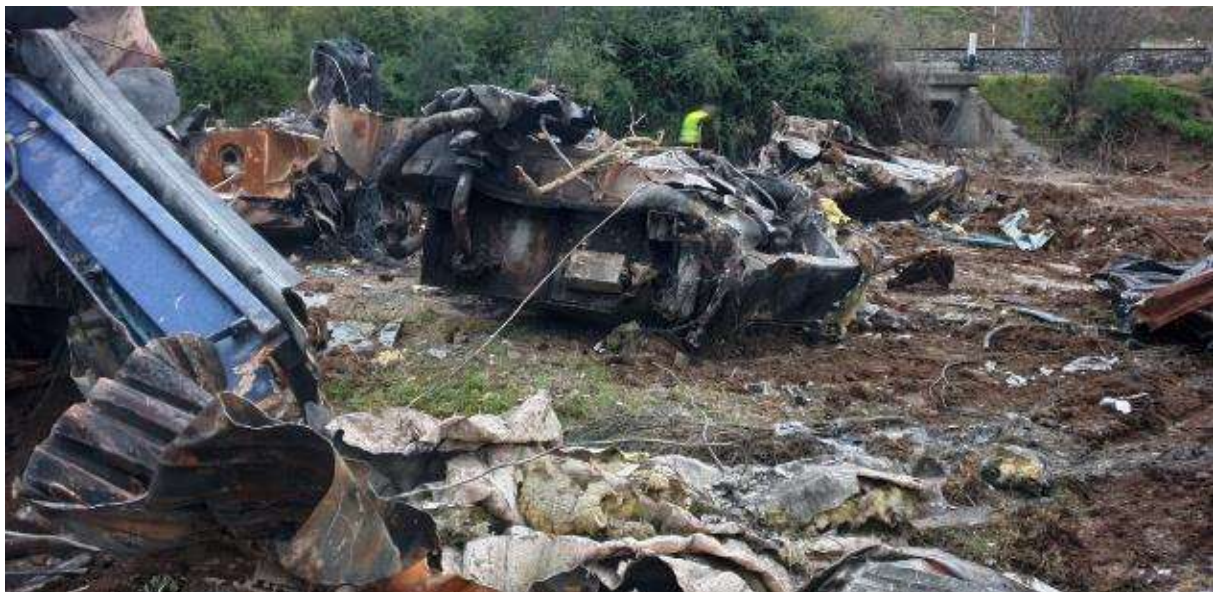
Important to mention is that the catenary poles at the time of the accident (seems now be placed a bit further down to the tunnel) were standing at the accident location (about 50 meters from the tunnel as can be seen from the Google Earth view from before the crash). The passenger train locomotive took during the crash trajectory the catenary pole down and most probably carried the overhead wire till the landing of the locomotive parts in the berm. The catenary wire can be found in several locations in the debris of the remaining locomotive frame with the transformer as shown in Figure 14 and Figure 15.

From the pictures, Figure 14 and Figure 15 we can see that the broken overhead wire has been carried away with the locomotive and can be found in the debris of the locomotive frame and transformer which was laying upside down with one end dig into the ground.

Figure 14: Transformer Loc 120 023 showing catenary line on transformer - file: 20230305_184147.jpg

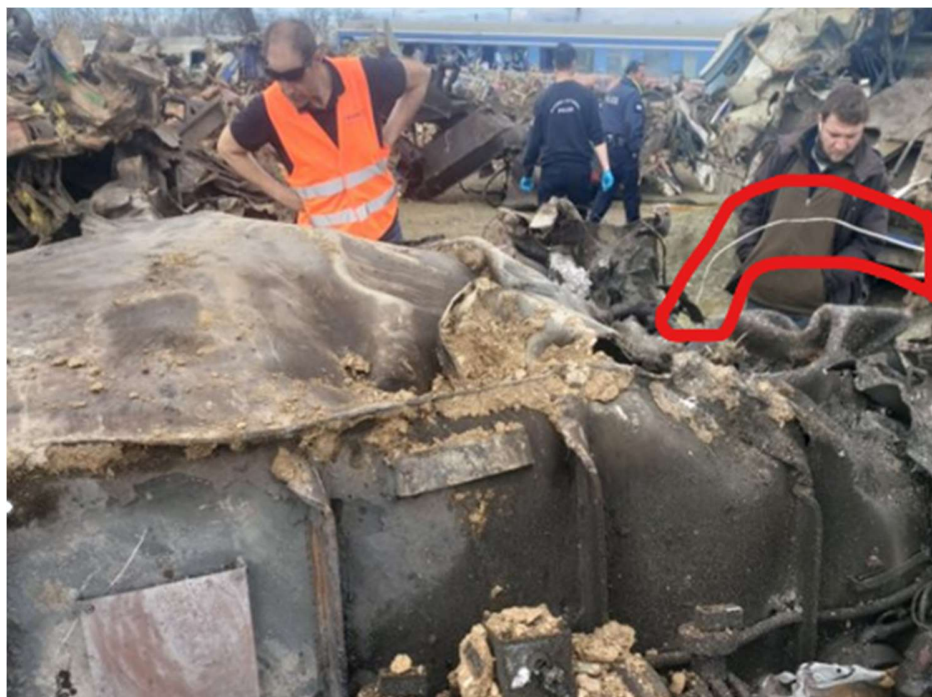
Figure 15: Transformer 120-023 with catenary line assembled Extract from file 230307_123525.jpg

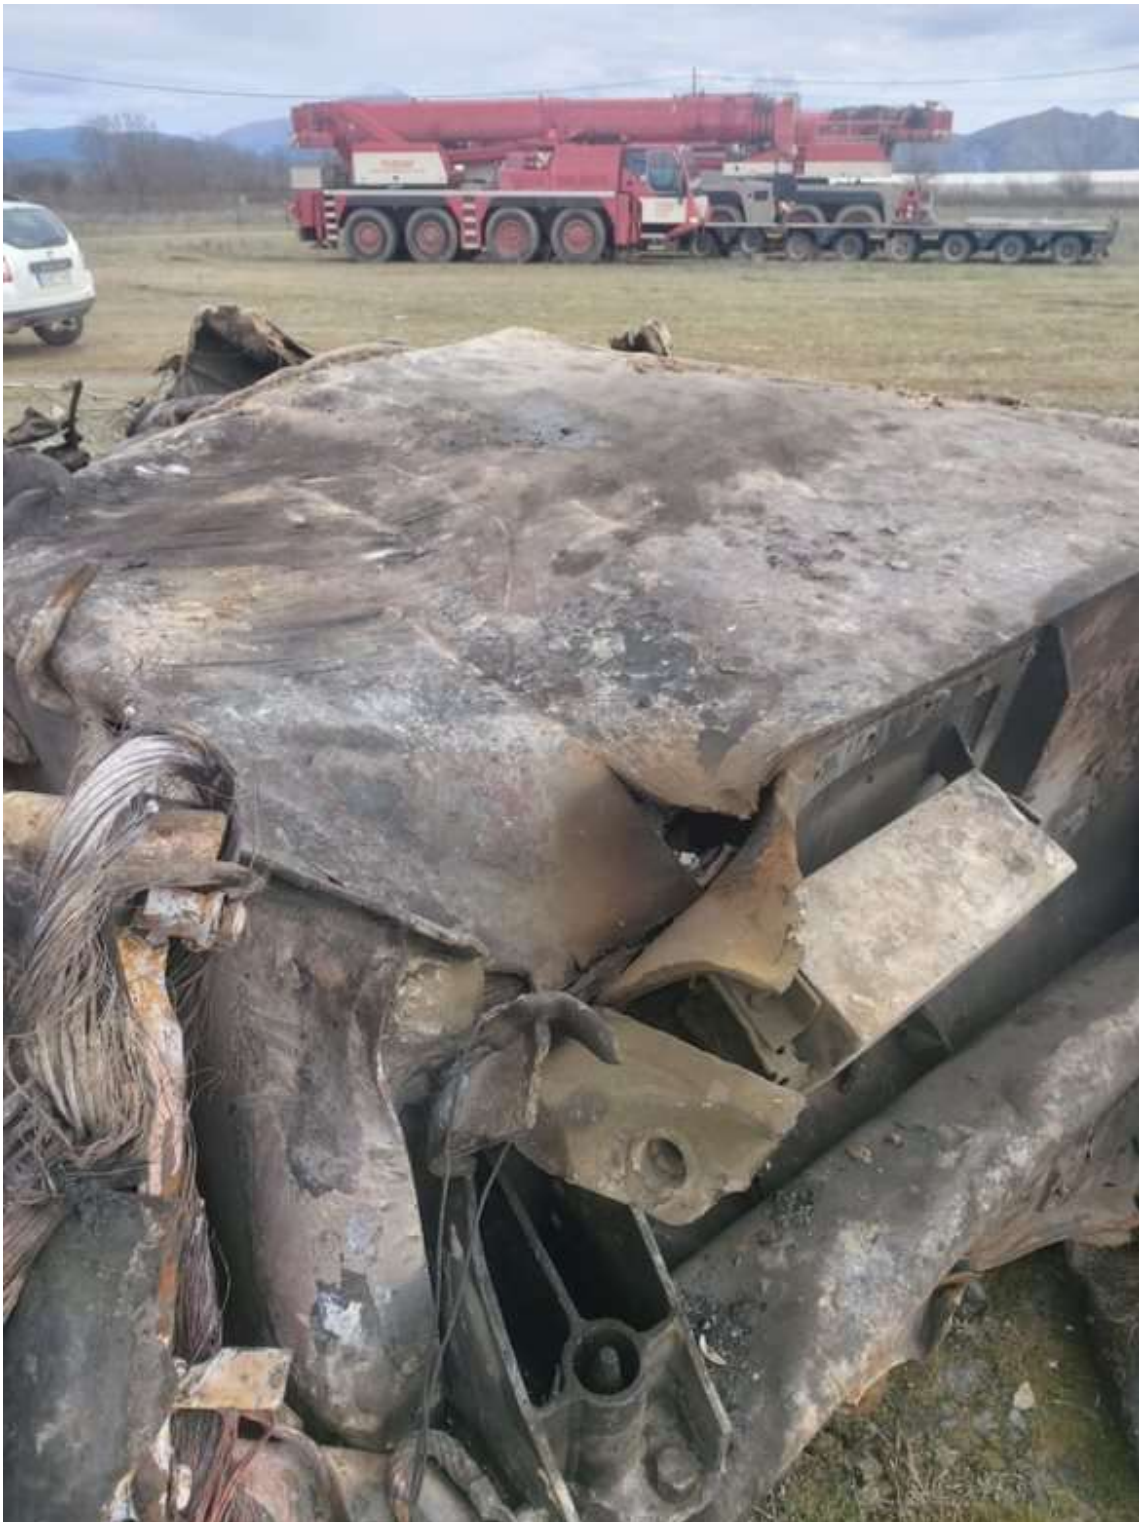
- On the transformer container, we can see in the picture Figure 16 a hole with the steel plates bended to the outside indicating a burst in the transformer container from an explosion inside. Giving the steel thickness (5 mm) of the container the hole should be caused by a rather big explosion.

Figure 16: Transformer 120023 with explosion hole - file: 230307_123509.jpg

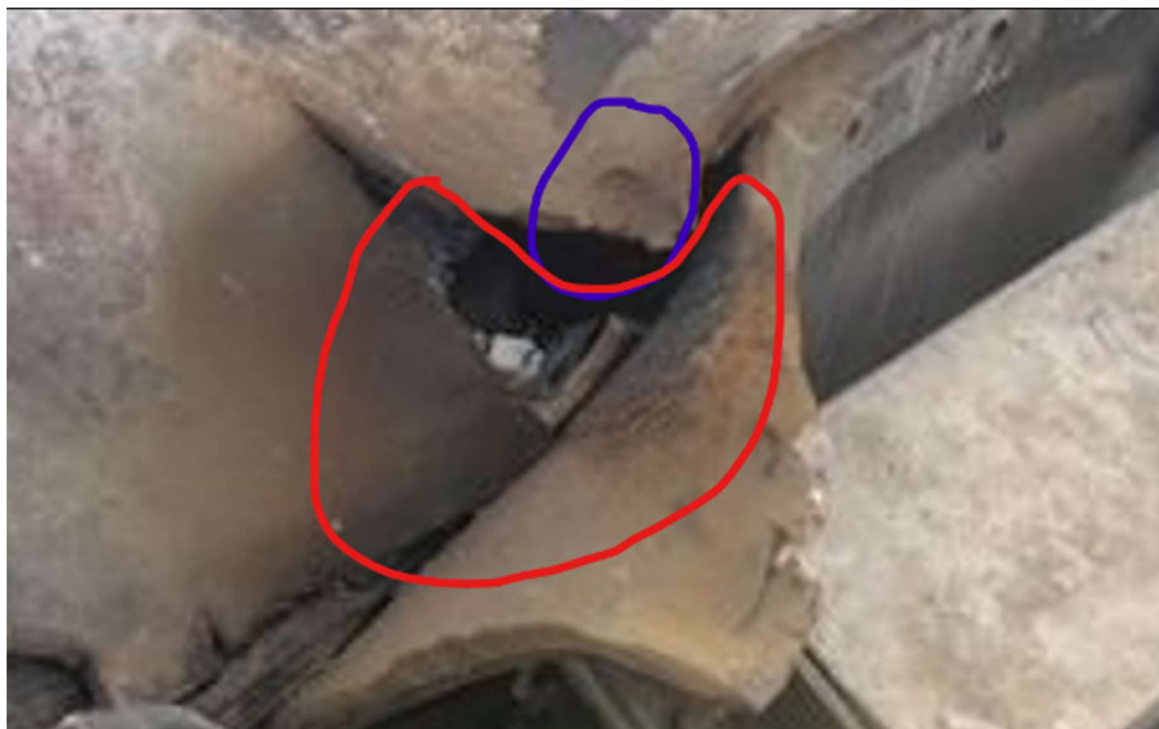
From the transformer picture, Figure 17, we can recognize a possible spot (blue marked) near the explosion hole where the short circuit on the transformer could have taken place. More detailed analysis is necessary to confirm this, but as this location was in the core of the subsequential explosion and fire /heat (see further) most evidence of the short circuit burned/melted away.

- At the explosion location on the transformer container, we can see on the color tint the different temperature the steel has had around the hole. One plate is bended downward indicating a very high temperature ($> 600^{\circ}\text{C}$). The different color tint also indicating that the fire had his source from this opening and the fire burned like a kind of 'Bunsen burner'. Also, soot is visible at that location indicating a longer fireplace as can be seen in the red marked area on picture Figure 17.

Figure 17: Detail explosion hole - file : 230307_123509.jpg

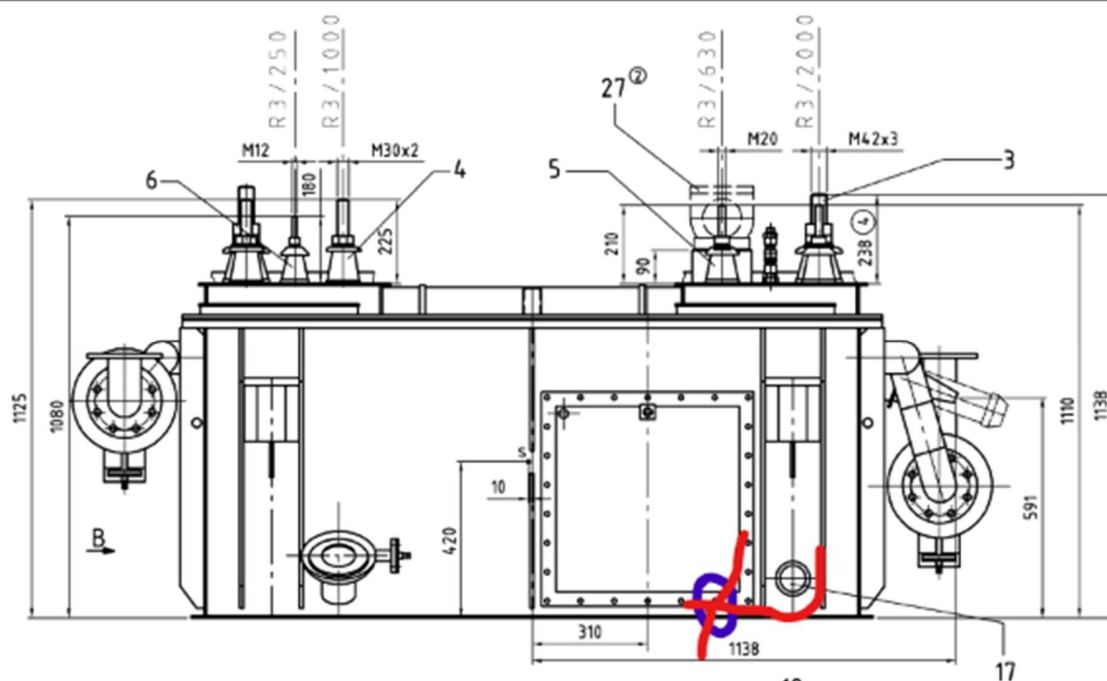
- The transformer container bottom plate, after the crash laying on top, is showing on the whole surface heavy heat deformations and different color tints indicating the location of the fire source and the high temperatures during a longer period (see picture Figure 20Figure 18).

Figure 18: Drawing Siemens Transformer with indication of possible flash point (blue) and torn open sheets (red)

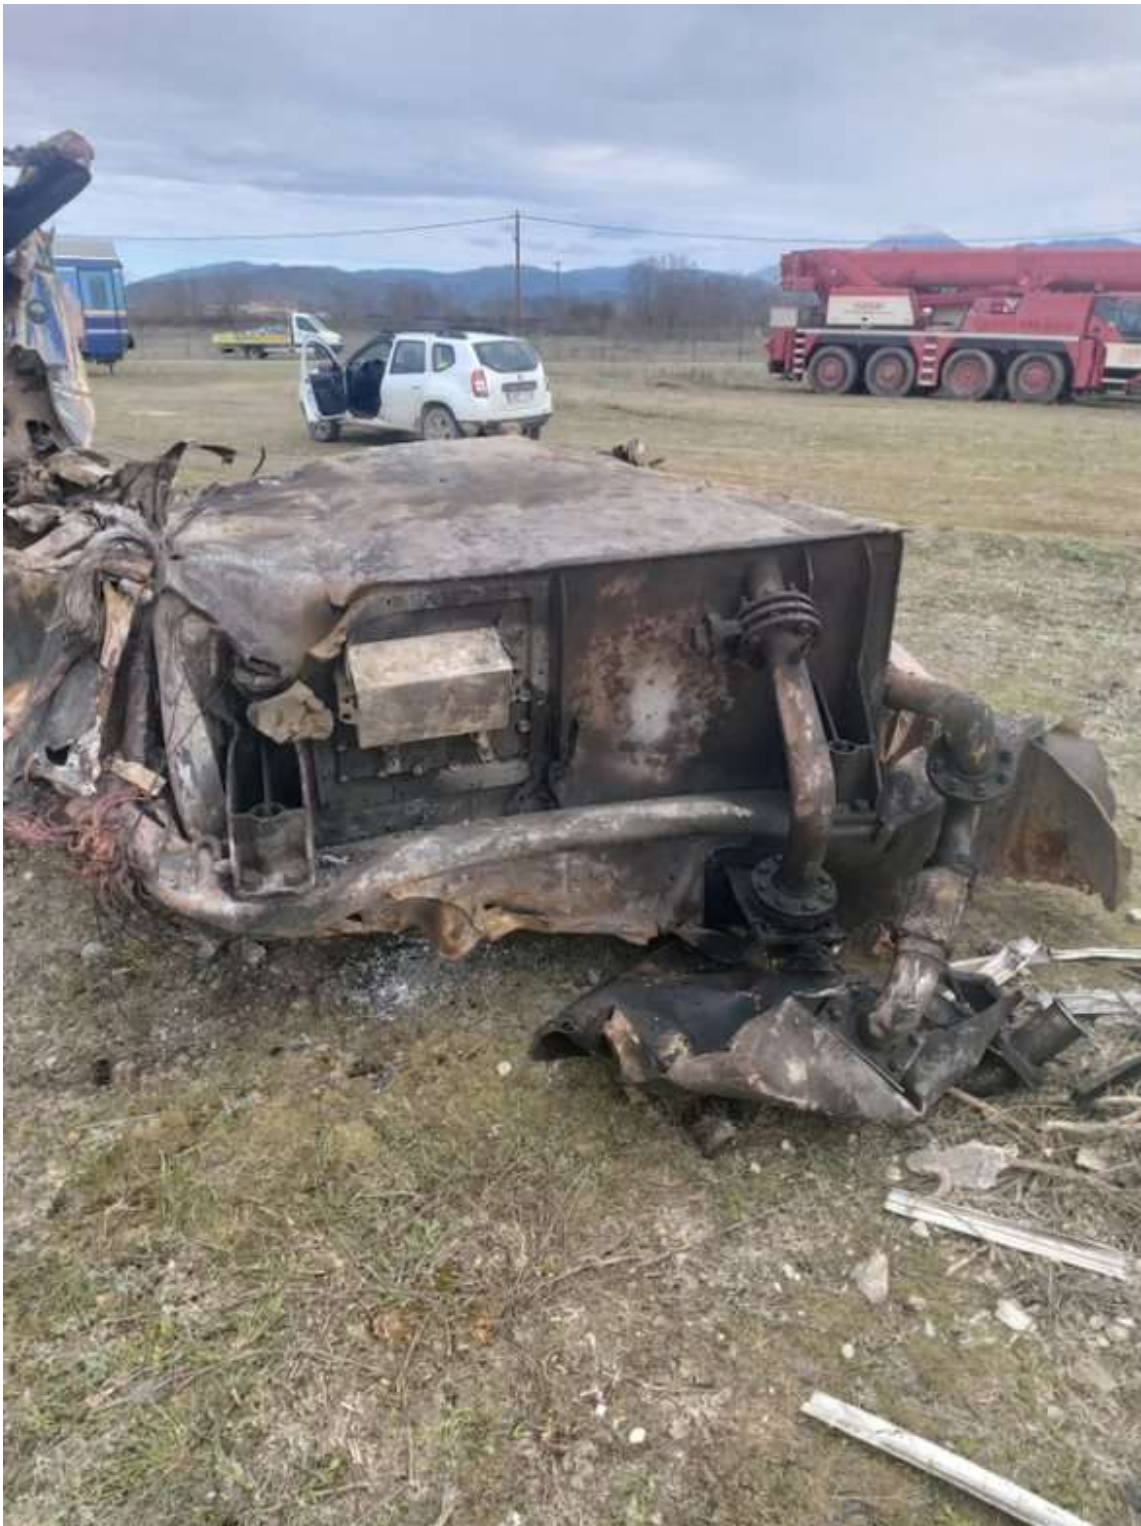
- The cover of the net filter capacitors in that same explosion location seems also to be blow away as no screw nor cover part can be found despite bolted with 26 bolts of M10 and the capacitor itself nor the capacitor fixation is much mechanical destroyed (white box on Figure 19).

Figure 19: transformer from same view as drawing (here upside down in debris)

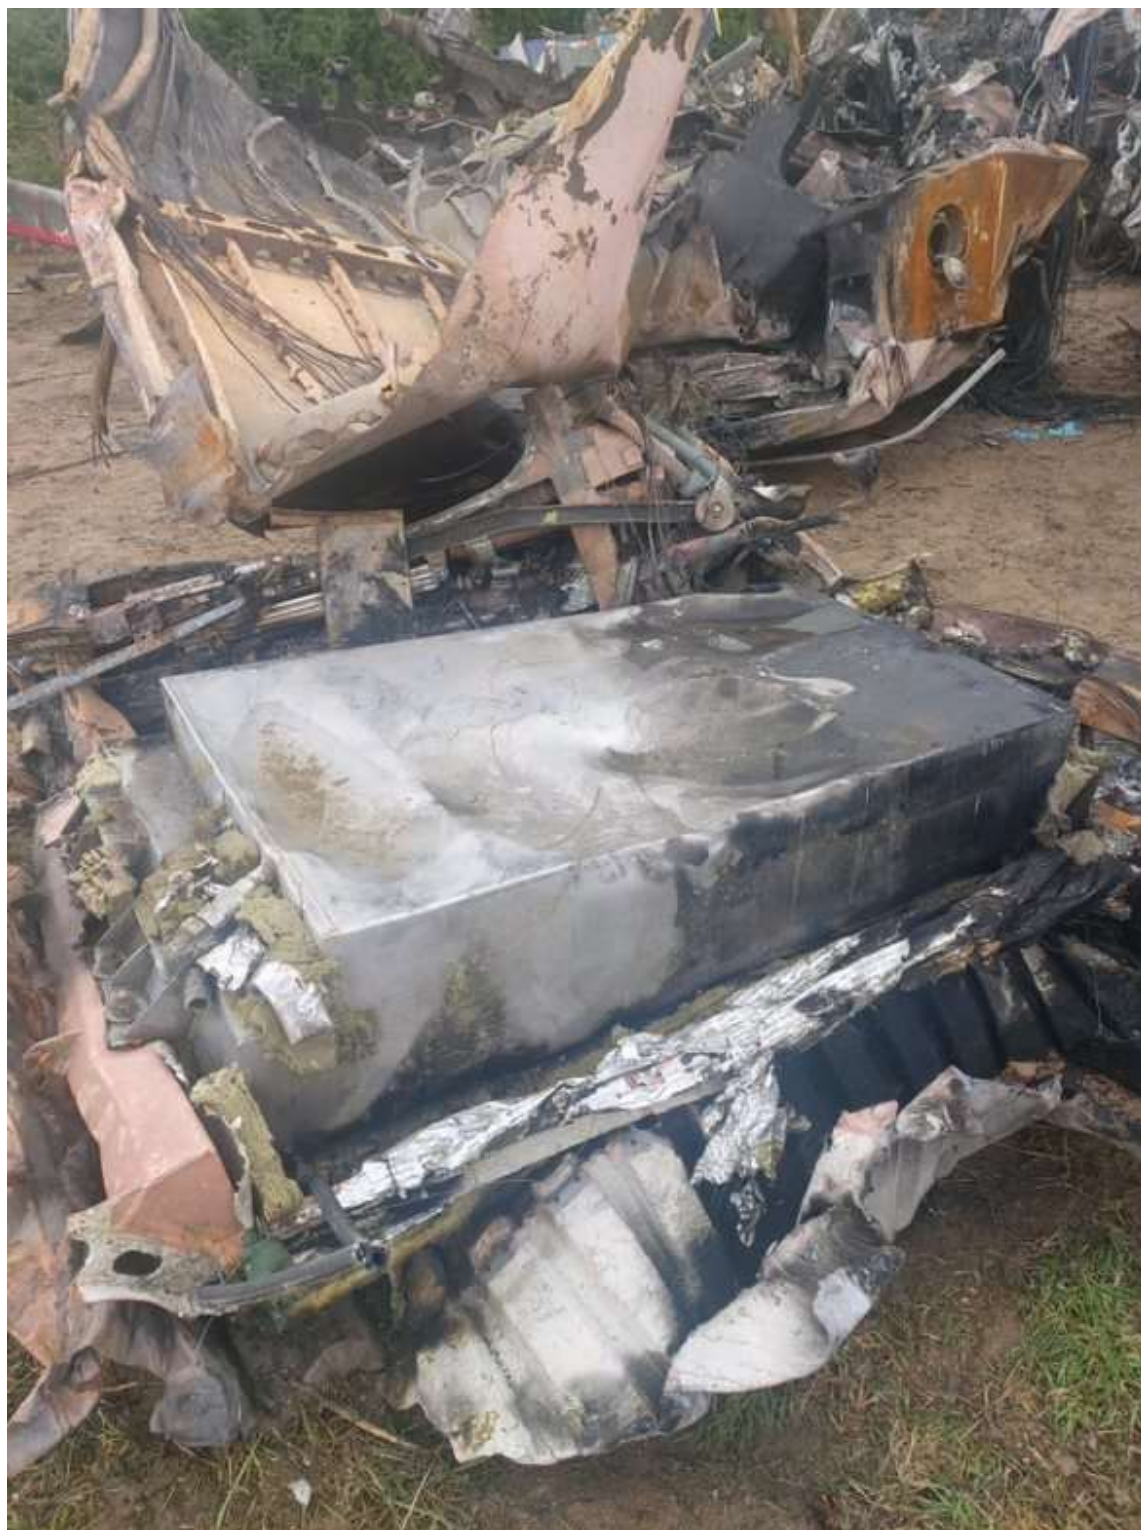
Figure 20: Transformer bottom view (on top in wreckage) file: 230303_104150.jpg

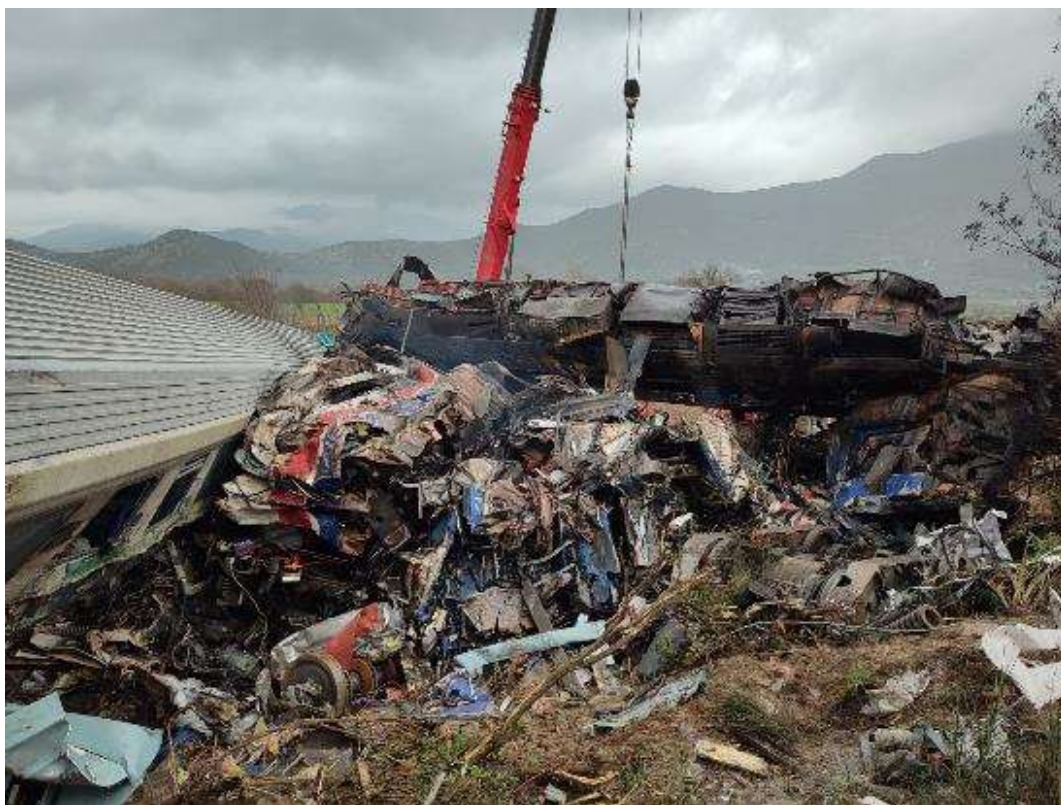
Figure 21: wreckage around transformer and fireplace - file: 230301_073502.jpg

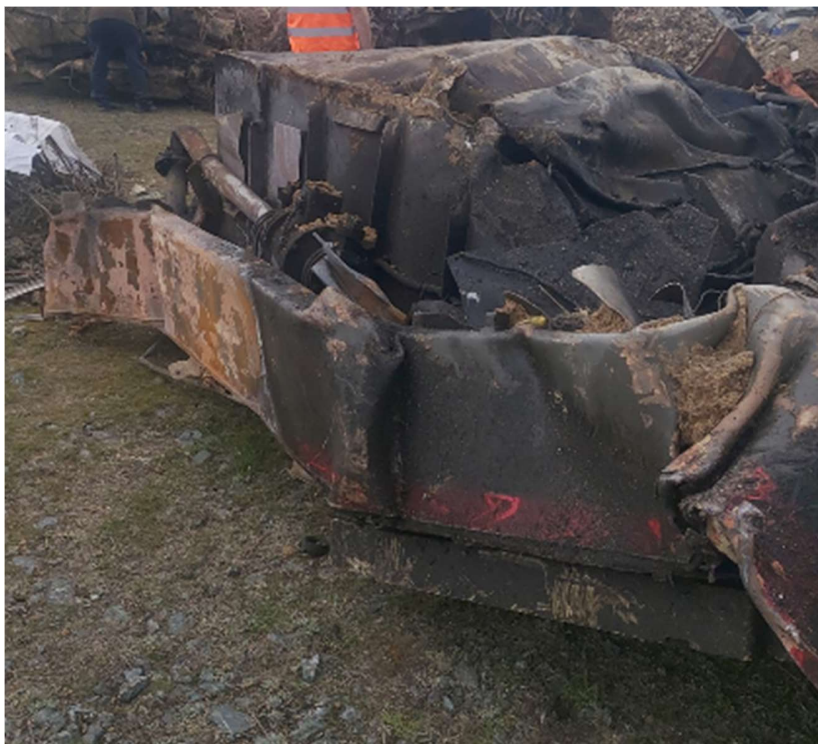
- The other site of the same transformer box / locomotive frame is heavy mechanical destroyed, even the carbody-bogie pivot point is bended inside this area, but it does show far less heavy fire marks, basically blackened by root and even some paint color is still visible (see Figure 22). It should be also noted that this part of the transformer was laying partly dig onto the ground while the other end (site explosion hole) was slightly up in the air.

Figure 22: Transformer opposite site explosion & fire hole (extract file : 20230307_124.106.jpg)
