HELLENIC TRAIN- RAILWAY COMPANY SOCIETE ANONYME

INVESTIGATION

on Accident dynamics, explosion, and fire

Collision between Intercity train 62 and freight train 63503
on 28 February 2023

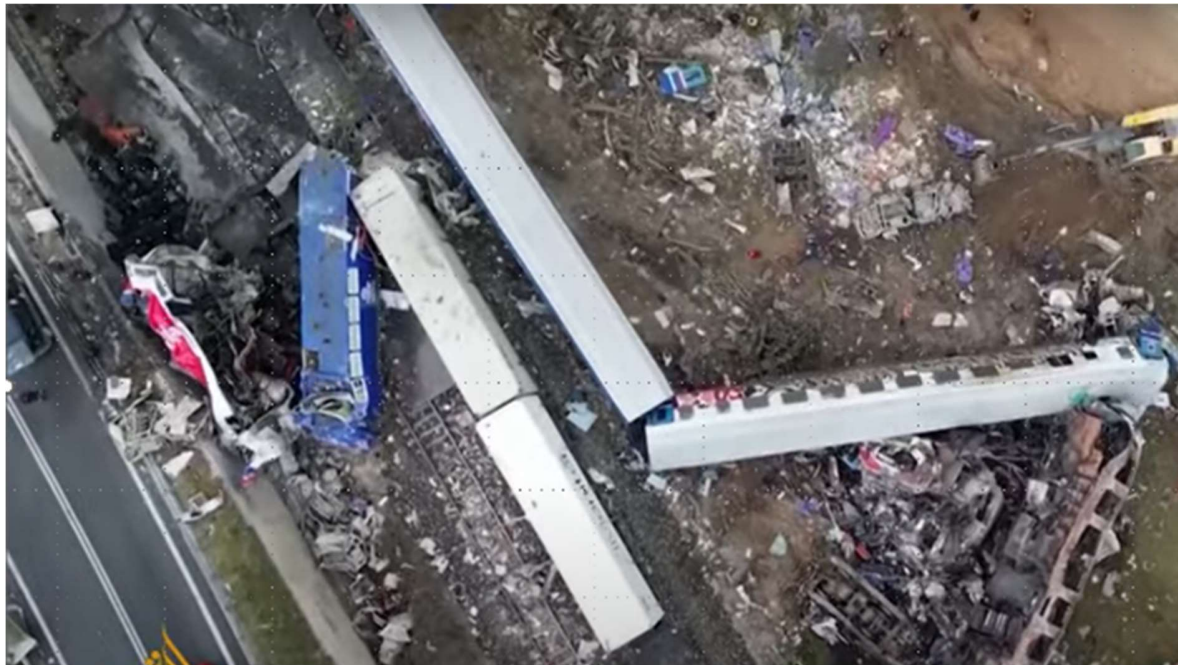
The first freight locomotives 120-022 was catapulted over the upward line track (driving direction leftwards) and heavily smashed against the motorway wall with equipment going over the wall (Figure 9). The locomotive most likely jumped up (headstock bended downwards) and took the overhead pole and catenary line with it in the crash trajectory as the catenary and catenary pole can be found under the locomotives (see Figure 11 and Figure 12).

- Despite the very heavy explosion and long fire, the debris around the transformer and in a wider area on the ground do not show fire marks as the color of some vehicle parts is still visible. Only the parts right on top of the fireplace are burned (Figure 9 and Figure 21Figure 20). This confirms that the fire was very heavy but very local and fueled from the transformer refrigerant fluid out of the container through the explosion hole in a type of "Bunsen burner" fire. The lower level of the debris was providing air/oxygen to the fire from below.

Figure 9: Drome view Freight locomotives and Passenger locomotives (screenshot video ABCNL news)
